U.S. CHEMICAL SAFETY AND HAZARD INVESTIGATION BOARD

INVESTIGATION REPORT

PETROLEUM PRODUCTS FACILITY INCIDENT

THIRD COAST INDUSTRIES

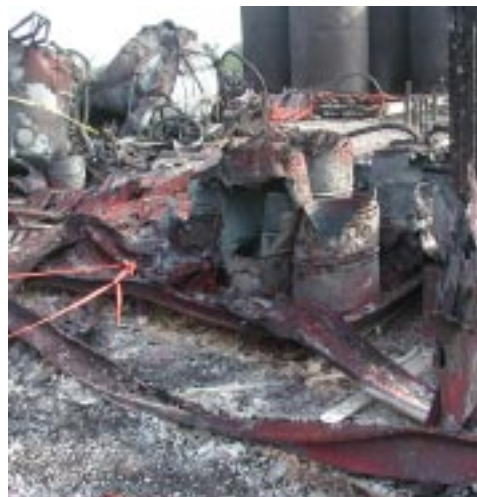
Figure 6. Drums located at packaging line 4.

Approximately 10 drums of combustible liquid were located on and around packaging line 4, just outside warehouse 1 (Figure 6). The drums would have loosely surrounded the worktable, where the security guard observed the initial fire. Evidence indicates that these drums ruptured due to internal pressure and released their contents, which subsequently ignited. The sounds heard by the Pearland Fire Chief upon his arrival on scene were most likely caused by the drums rupturing.

The drums at packaging line 4 were of standard metal construction without drum relief devices. This device is a plastic closure that melts during fire exposure and remains open, allowing pressure to vent. It is an option for flammable and combustible liquid containers. The drum relief device protects the container from failure, which would release the entire contents, and also helps prevent the risk of drums rocketing into the air and causing damage when they fall. Empty drums were found on property surrounding the Third Coast site.

Evidence indicates that these drums ruptured due to internal pressure and released their contents, which subsequently ignited.

The Pearland Fire Chief's initial observation of a pool fire surrounding the box vans and the tank wagon indicates that the drummed material near packaging line 4 was likely the first large quantity of liquid involved in the fire. Steel drums exposed to a pool fire will typically rupture within 5 to 15 minutes due to the buildup of internal pressure. "The end result of a sealed drum exposed to fire is the violent failure of the container" (FM, 2000b). When the drums ruptured, their contents added more fuel to the growing fire and spread it faster.

Steel drums exposed to a pool fire will typically rupture within 5 to 15 minutes due to the buildup of internal pressure.

Although drum relief devices do not prevent ultimate failure and release of liquid contents when exposed to a long-duration fire, they do allow for longer retention of liquid. If the Third Coast drums had been equipped with relief devices, it is likely that they would have largely vented pressure rather than rupturing.

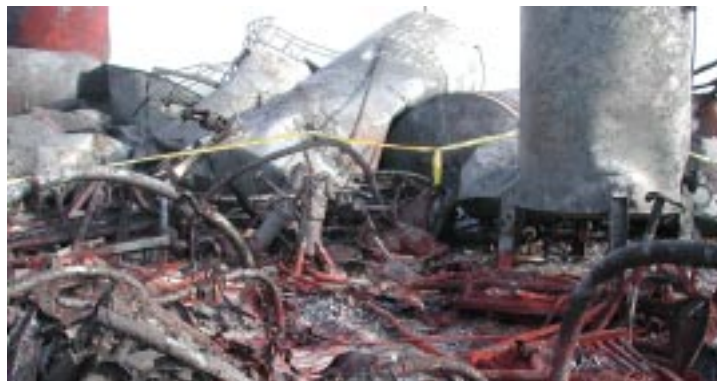
Figure 7. Collapsed blend tanks located near warehouse 1.

Several 2,000-gallon blend tanks were located to the northeast of warehouse 1. The tanks were supported about 3 feet above ground by steel legs with no external fireproofing. As the pool fire surrounded this area, the legs buckled, and the tanks toppled and contributed their contents to the fire (Figure 7).

As the pool fire surrounded this area, the [tank] legs buckled, and the tanks toppled and contributed their contents to the fire.

The blend tanks were located directly adjacent to the storage tank farm, separated by a low dike wall. In addition, numerous steel pipes from the storage tanks traversed the dike walls. Although valves were closed at the end of each pipe, the lines were typically not isolated with closed valves at the storage tanks. As the pipelines failed due to fire exposure, they released materials from the storage tanks that also contributed to the pool fire.

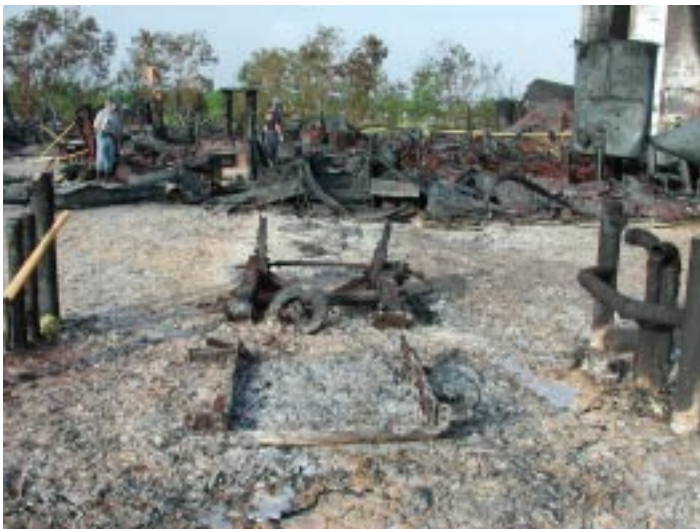
Figure 8. Remains of tank wagon, front end in foreground. (Note pools of melted and resolidified aluminum.)

An aluminum tank wagon containing a combustible liquid synthetic motor oil (flash point > 400°F) was located within 6 feet of packaging line 4, where the security guard initially observed the fire. Third Coast was repackaging the material from the tank wagon into smaller containers for retail sale. The Pearland Fire Chief saw this tank wagon engulfed by the pool fire. The tank was venting, indicating that it was already being heated to a significant temperature.

In a fire of this type, aluminum rapidly weakens and melts. All that remained of the liquid compartment of the tank wagon after the fire were several pools of aluminum, as shown in Figure 8. The tank wagon's load of fuel contributed to the ground fire, which flowed toward the storage tanks and the warehouses.

The tank wagon's load of fuel contributed to the ground fire, which flowed toward the storage tanks and the warehouses.

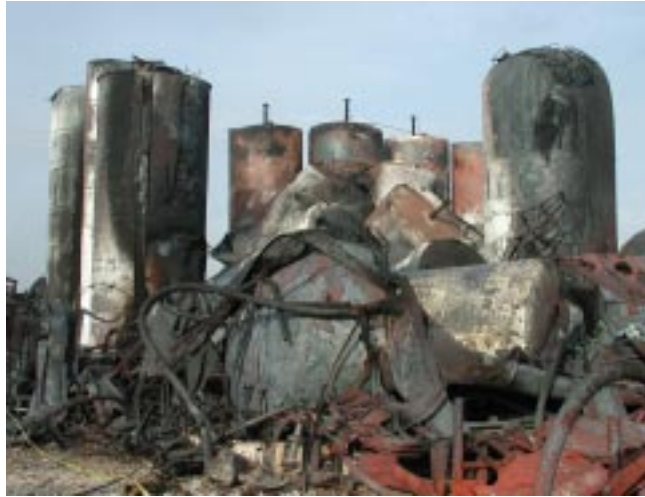
Figure 9. Failed storage tanks.

The Third Coast facility lacked adequate drainage or containment to prevent liquids released from the drums, blend tanks, and tank wagon from flowing toward the rest of the facility or offsite. The dike wall on the south side of the tank farm, closest to the fire origin, was composed of two courses of hollow cinderblock. The cinderblock was broken in places and mortared joints were cracked, which allowed the burning liquid to enter the tank farm and begin pooling around the storage tanks. The intense heat from the fire caused the bulk storage tanks to fail, either by overpressure or collapse; the containerized combustible liquids stored inside burned and destroyed the warehouse buildings (Figures 9 and 10).

The storage tank areas at Third Coast were not designed to limit the spread of fire. Because the tanks did not have relief devices suitable for external fire scenarios, they catastrophically ruptured and released their contents rather than venting to the atmosphere. NFPA 30 and OSHA 1910.106 require that aboveground storage tanks have emergency relief venting in the form of construction⁵ or a device

Because the tanks did not have relief devices . . . they catastrophically ruptured and released their contents rather than venting to the atmosphere.

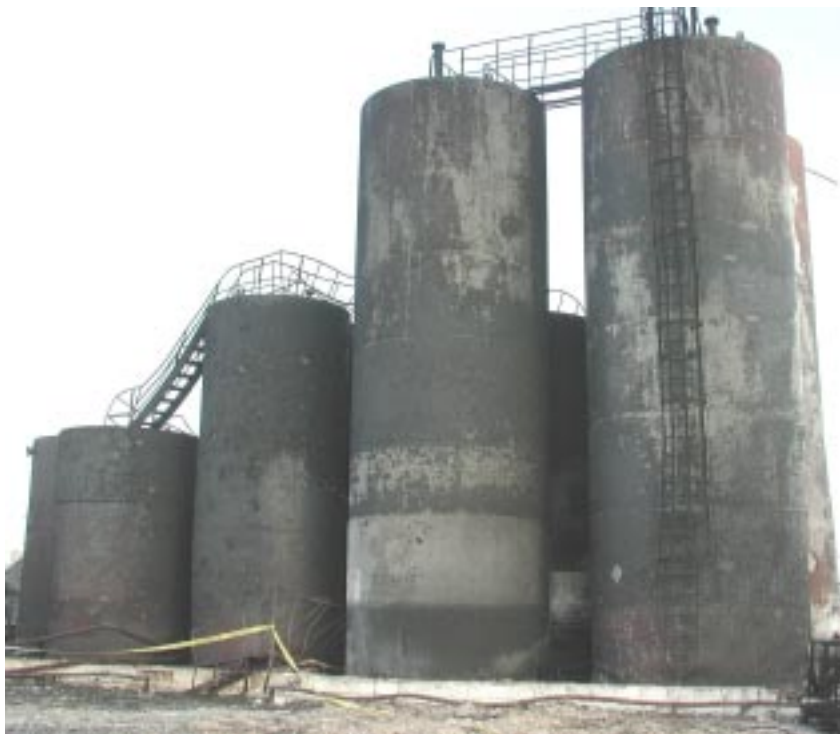
Figure 11. Section of south dike wall, storage tank farm.

The cinderblock [wall] was broken in places and mortared joints were cracked, which allowed the burning liquid to enter the tank farm and begin pooling around the storage tanks.

The storage tanks were located within 1 foot of the dike wall; in the vicinity of the initial fire, the wall was composed of two courses of hollow masonry cinderblock. The wall was in poor condition and cracked in some spots (Figure 11), which facilitated spread of the pool fire. Because of the proximity of the tanks to the wall and processing areas, radiant heat from the pool fire would have heated the contents of the closest tanks.
