U.S. CHEMICAL SAFETY AND HAZARD INVESTIGATION BOARD

INVESTIGATION REPORT

PETROLEUM PRODUCTS FACILITY INCIDENT

THIRD COAST INDUSTRIES

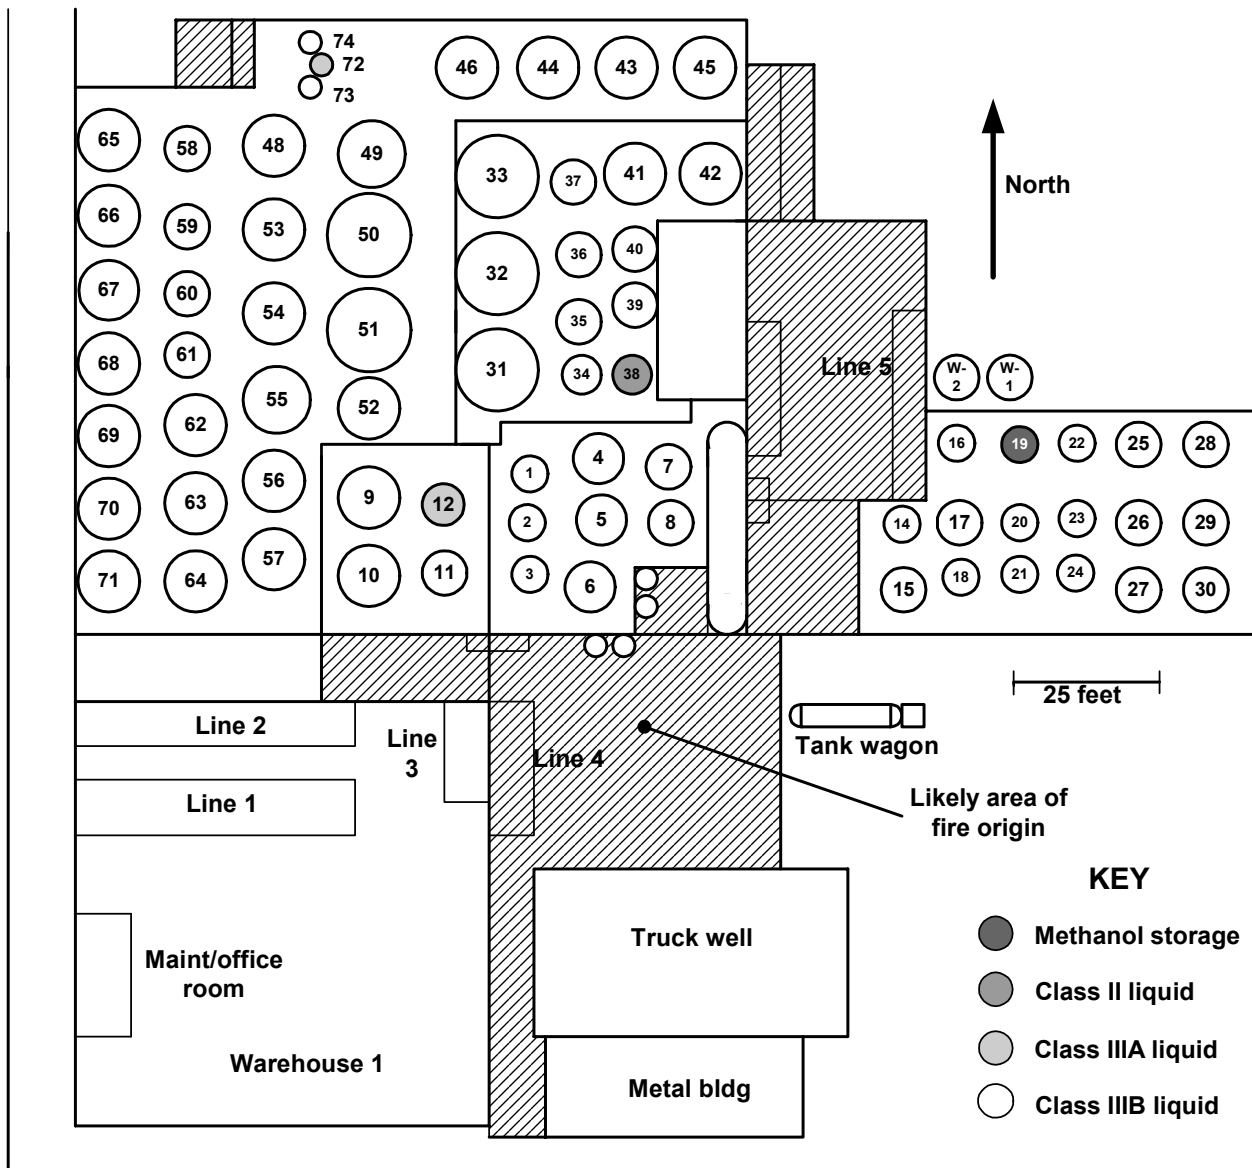
Figure 3. Third Coast storage tank farm.

Seventy-four storage tanks were in use at the time of the fire (Figure 3). Another 18 storage tanks were installed, but not in use. The tanks were divided among five diked areas. The rudimentary diking generally consisted of two courses of hollow masonry blocks. Although most of the tanks contained Class IIIB liquids, both raw materials and bulk finished products, the following liquids were also stored onsite:

- In Tank 19: 4,400 gallons of methanol (flash point 52°F), a Class IB material used in the production of windshield washer fluid.
- In Tank 38: 3,500 gallons of mineral spirits, a Class II material (flash point 105°F).

- In Tanks 12 and 72: 9,500 gallons of a Class IIIA petroleum distillate (flash point 150°F) and 1,050 gallons of an automatic transmission fluid (flash point 198°F), respectively.
